Subject: Product Improvement of Dexter Vortex™ Axle Removable Grease Caps

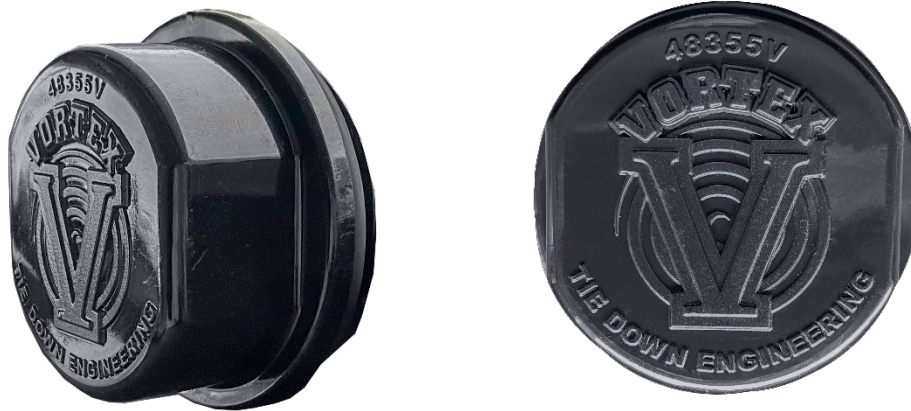
Old Cap:

Dexter has recently made several improvements to the end cap and O-ring assembly for Dexter's Vortex lubrication system. These improvements will enhance product durability, sealing, and product identification. Upgraded caps fit all Vortex axles up to 4,200 lbs. capacity. Axles equipped with Vortex lubrication system have an internally threaded hub, hub-rotor, or hub-drum nose dimensions of 2.33". The original caps, formerly Tie Down part number 48355V, can be identified by their pressure-sensitive label with the Vortex product identification or a similar Vortex identification molded into the cap.

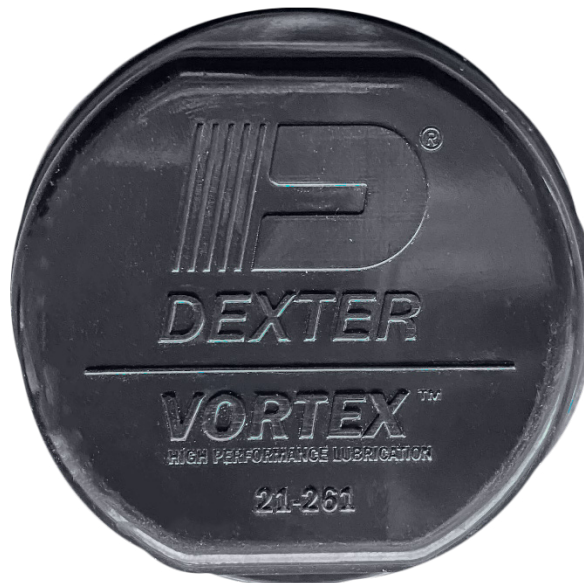
New Cap:

The new caps, Dexter part number 021-261-01 can most easily be identified by their new Dexter branding and the wording "VORTEX™ High Performance Lubrication" molded into the cap.

The new cap utilizes improved tooling and enhanced material. These changes increase cap strength and provide improved resistance to the elements and the operational environment. The cap threaded nose has been re-dimensioned to ease cap installation into the axle hub during service. In addition, the new cap assembly includes a new O-ring with dimensions of 2.11" x 0.14" for superior cap torque retention and sealing characteristics. This upgraded 021-261-01 cap assembly is a running change applied to newly manufactured axles and cap assemblies sold separately in service parts kits. The 021-261-01 cap assembly can also replace caps on prior axles that used the 48355BV cap.

The caps are installed initially by hand in clockwise rotation, square into the hub to prevent cross-threading. Continue rotating the cap by hand until the O-ring is snug between the hub nose and cap. Then finally, tighten the cap only an additional quarter to half turn with a wrench via the wrench flats molded into the cap. Installation of the improved cap is similar to installing an automotive oil filter.
